MEMORANDUM

RE: Riverwoods Site Utility Investigation

Abonmarche was retained by South Haven Township to perform a site utility investigation for the "Riverwoods" property, located in South Haven Township, in which the MDNR has an interest. The site is located to the west of I-196, to the east of Blue Star Highway, the north of 2nd Avenue, and the south of the Black River. The overall parcel is 59.64 acres.

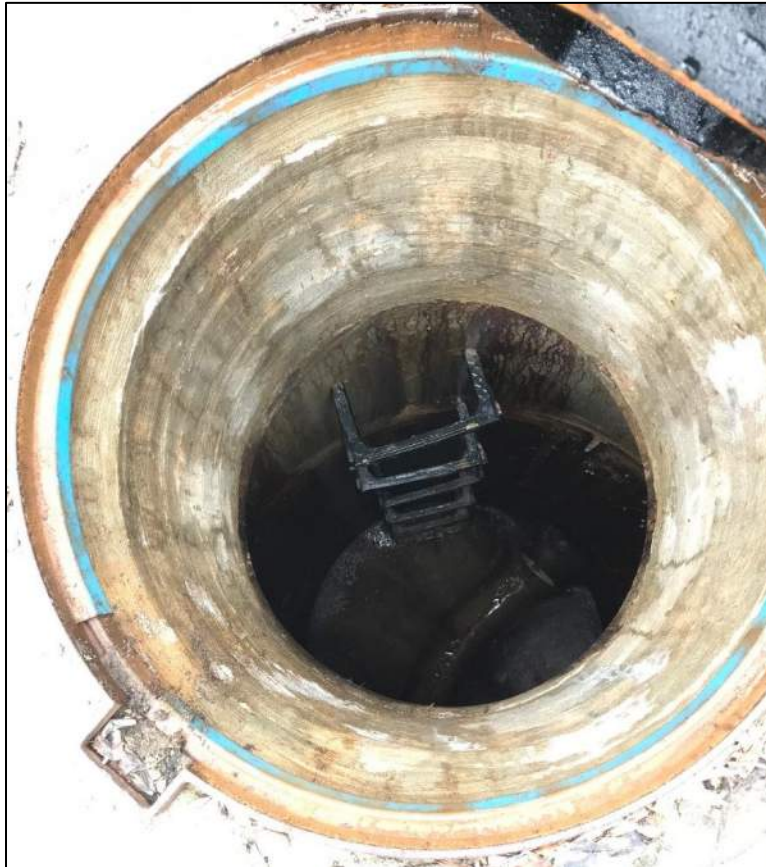
Figure 2: Typical Sanitary Manhole Condition

A visual review of the sanitary manhole structures was conducted during the site investigation. The manholes and castings are generally in like new condition as they have not been subjected to sanitary flows or a large number of vehicular loads. There is evidence of calcium buildup in the flow channels which should be removed to ensure proper operation of the system.

Without performing CCTV analysis of the pipe network, which was beyond the scope of this investigation, it cannot definitively be determined what maintenance or repairs are needed on the system. Anticipated repairs, considering that the main has not been under any live flows, would likely involve minor maintenance work such as cutting any root intrusions and removing debris in the system.

CCTV and cleaning quotes were obtained for the system in April 2018 and were around \$6,000 for light cleaning of the system along with video documentation. This cost would also cover the aforementioned cleaning of the flow channels to remove calcium deposits to allow for the CCTV equipment to properly operate. This fee does not include inspection of the condition of sanitary laterals which were quoted at about \$100 per lateral.

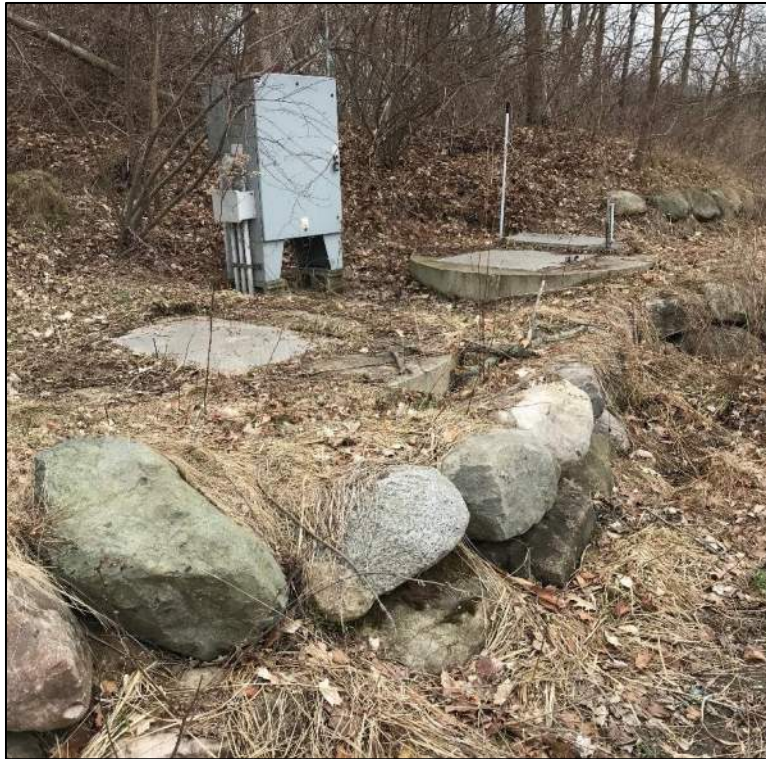
Figure 3: Riverwoods Lift Station Condition

In regards to the physical above ground condition of the lift station site, a few improvements will be required in order to fully certify the lift station as complete. The previous developer did not finish installation of a concrete pad around the station structure or the control panel. This will need to be completed to ensure City Staff can perform proper maintenance on the system and can access the station in the event of a power outage or other emergency. The original plans call for a 20 foot wide by 30 foot long pad at this location. In order to provide a proper base and a 6 inch thick concrete pad, including all needed cleanup and grading, around \$10,000 should be budgeted for this improvement.

Additionally, a 12 foot wide asphalt access route would also need to be installed from the roadway to the station to provide better access to the concrete pad for the aforementioned reasons. Assuming a 50 foot long drive with 3 inches of asphalt, a 6 inch aggregate base, and a 12 inch subbase with grading and necessary removals, around \$5,000 should be budgeted for this improvement.

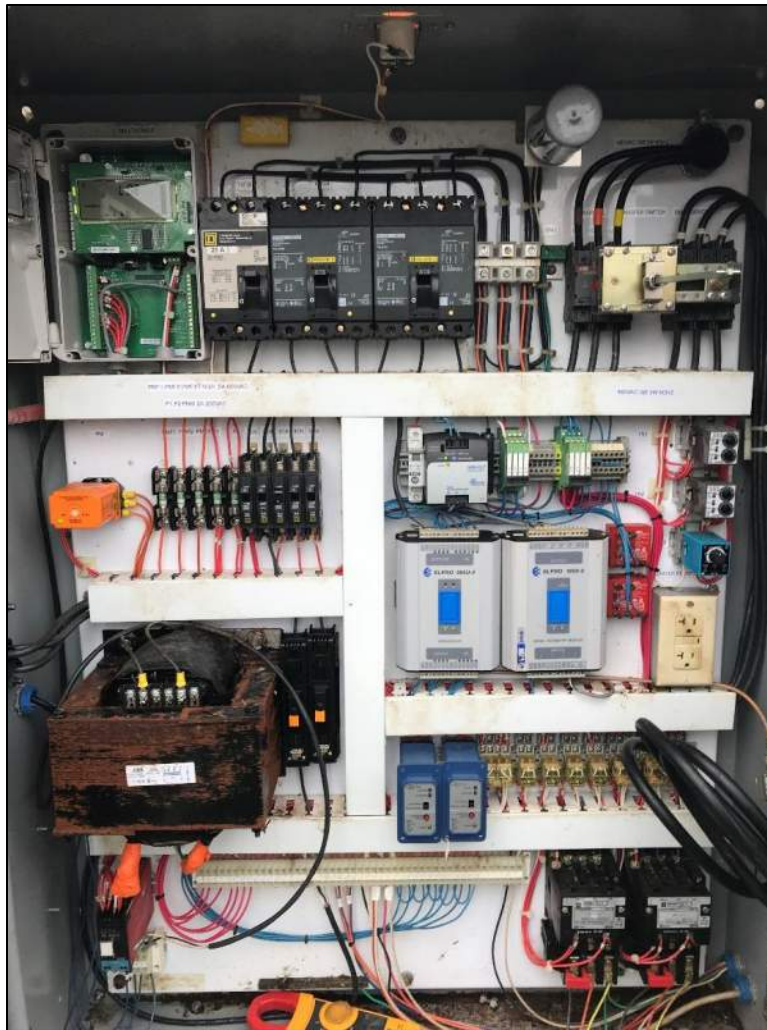
The internal condition of the control panel can be seen in the image on the following page. The panel is in operating condition and was cleaned out by the City as a rodent nest was found upon opening the panel. The only upgrade required for the panel would be to switch out the existing network control system and upgrade to the City's new Mission system so that any alarms or issues can be relayed directly to City Staff. This upgrade would cost roughly \$1,500.

Figure 4: Riverwoods Lift Station Condition – Control Panel

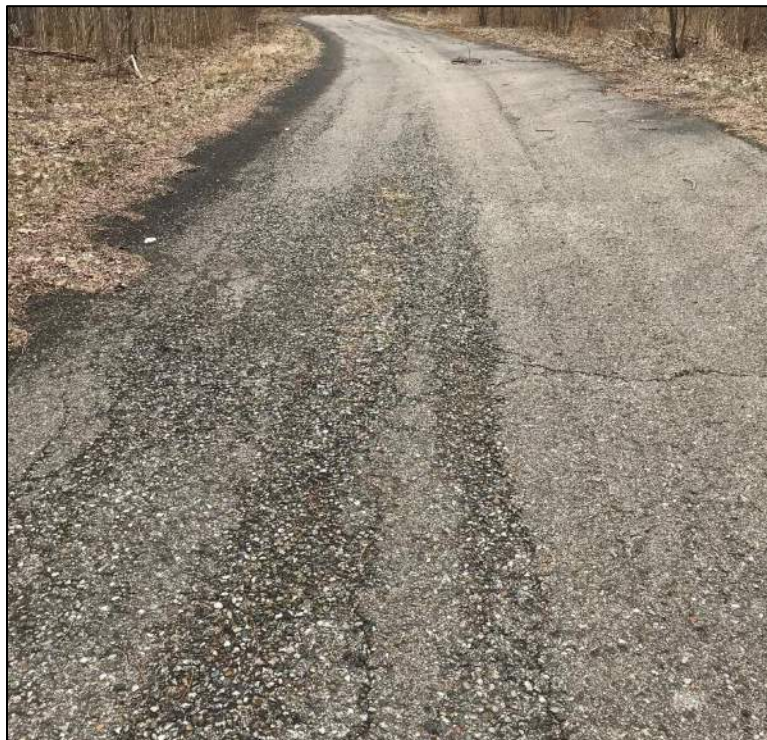
The current asphalt has experienced minimal traffic over the course of the 10 plus years it has been installed, however it has also not received any maintenance. Since the pavement section was not fully installed the roadway was low around drainage structures and water was allowed to sit on the road surface. Further, typical pavement weathering of the surface has occurred due to rain and snow on the surface leading to cracking and water intrusion.

The image below is representative of some of the worst sections of pavement in the development. There is evidence of significant alligator cracking and raveling of the pavement surface which should be addressed prior to top course paving. Budgeting for pavement work should include roughly 50 percent base course asphalt removal and replacement along with compaction of the base where pavement was removed. The work is estimated at \$58,000 which includes milling out damaged pavement sections, compacting the base course, and repaving a 1.5 inch section of base course asphalt prior to paving new top course asphalt.

Figure 5: Riverwoods Pavement Condition

• Pavement	
○ The pavement section has been installed except for the remaining 1.5 inches of top course	\$61,000
○ Prior to placing top course pavement, approximately 50 percent of the existing base course should be removed, the base compacted, and repaved to eliminate sections with excessive wear.	\$58,000

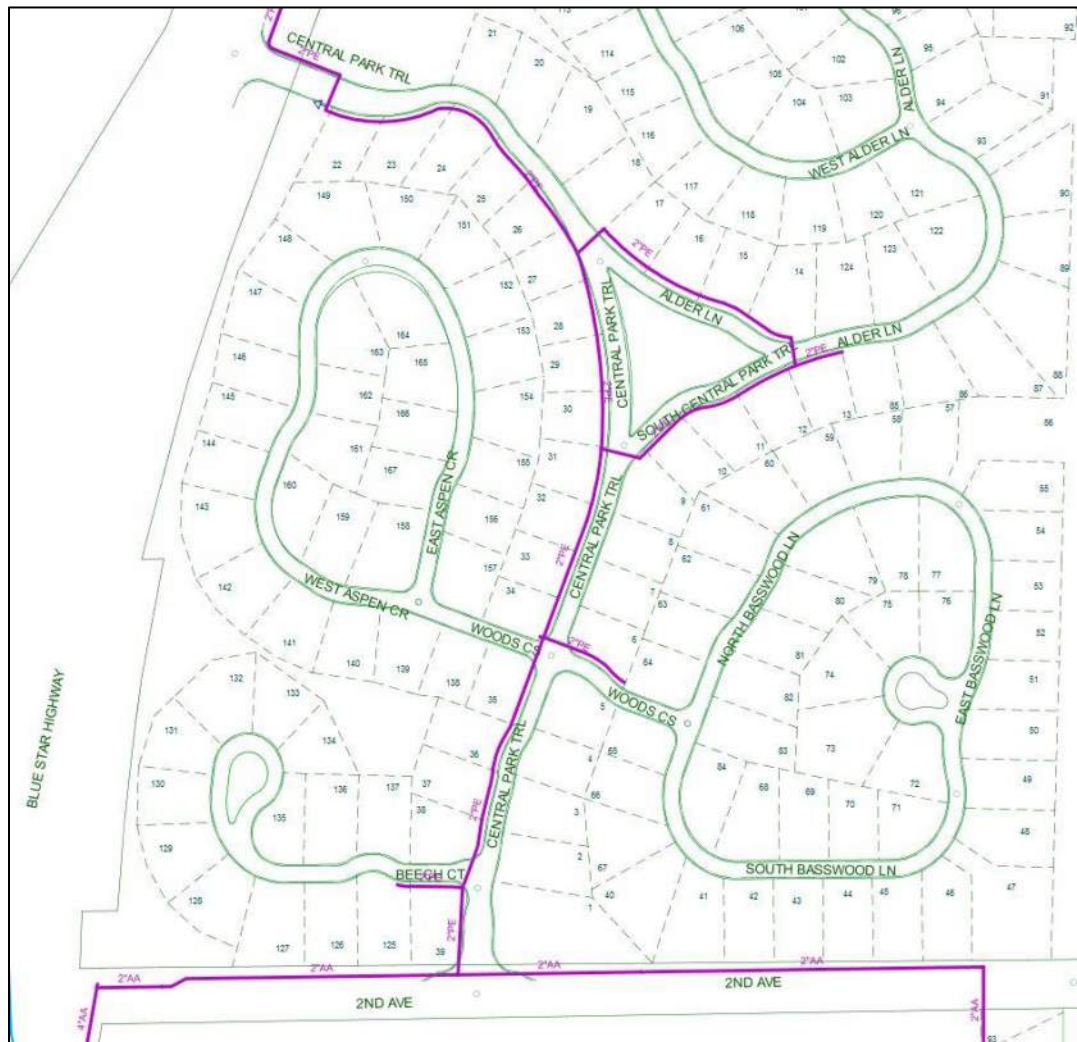
The new system is 2.0 inch polyethylene main throughout the developed areas of the site, with stubs provided for the remaining phases of work. This system is connected to the existing network via a 2.0 inch aluminum gas main located on 2nd Avenue on the southern border of the site. The future developer should work with the gas company to provide gas services and expansion of the system as required for full buildout of the development.

Figure 6: Riverwoods Gas Utility Map
